Report Number Y-1234

UNION CARBIDE NUCLEAR COMPANY  
DIVISION OF UNION CARBIDE CORPORATION

Y-12 PLANT

ACCIDENTAL RADIATION EXCURSION AT THE Y-12 PLANT  
June 16, 1958  
Final Report

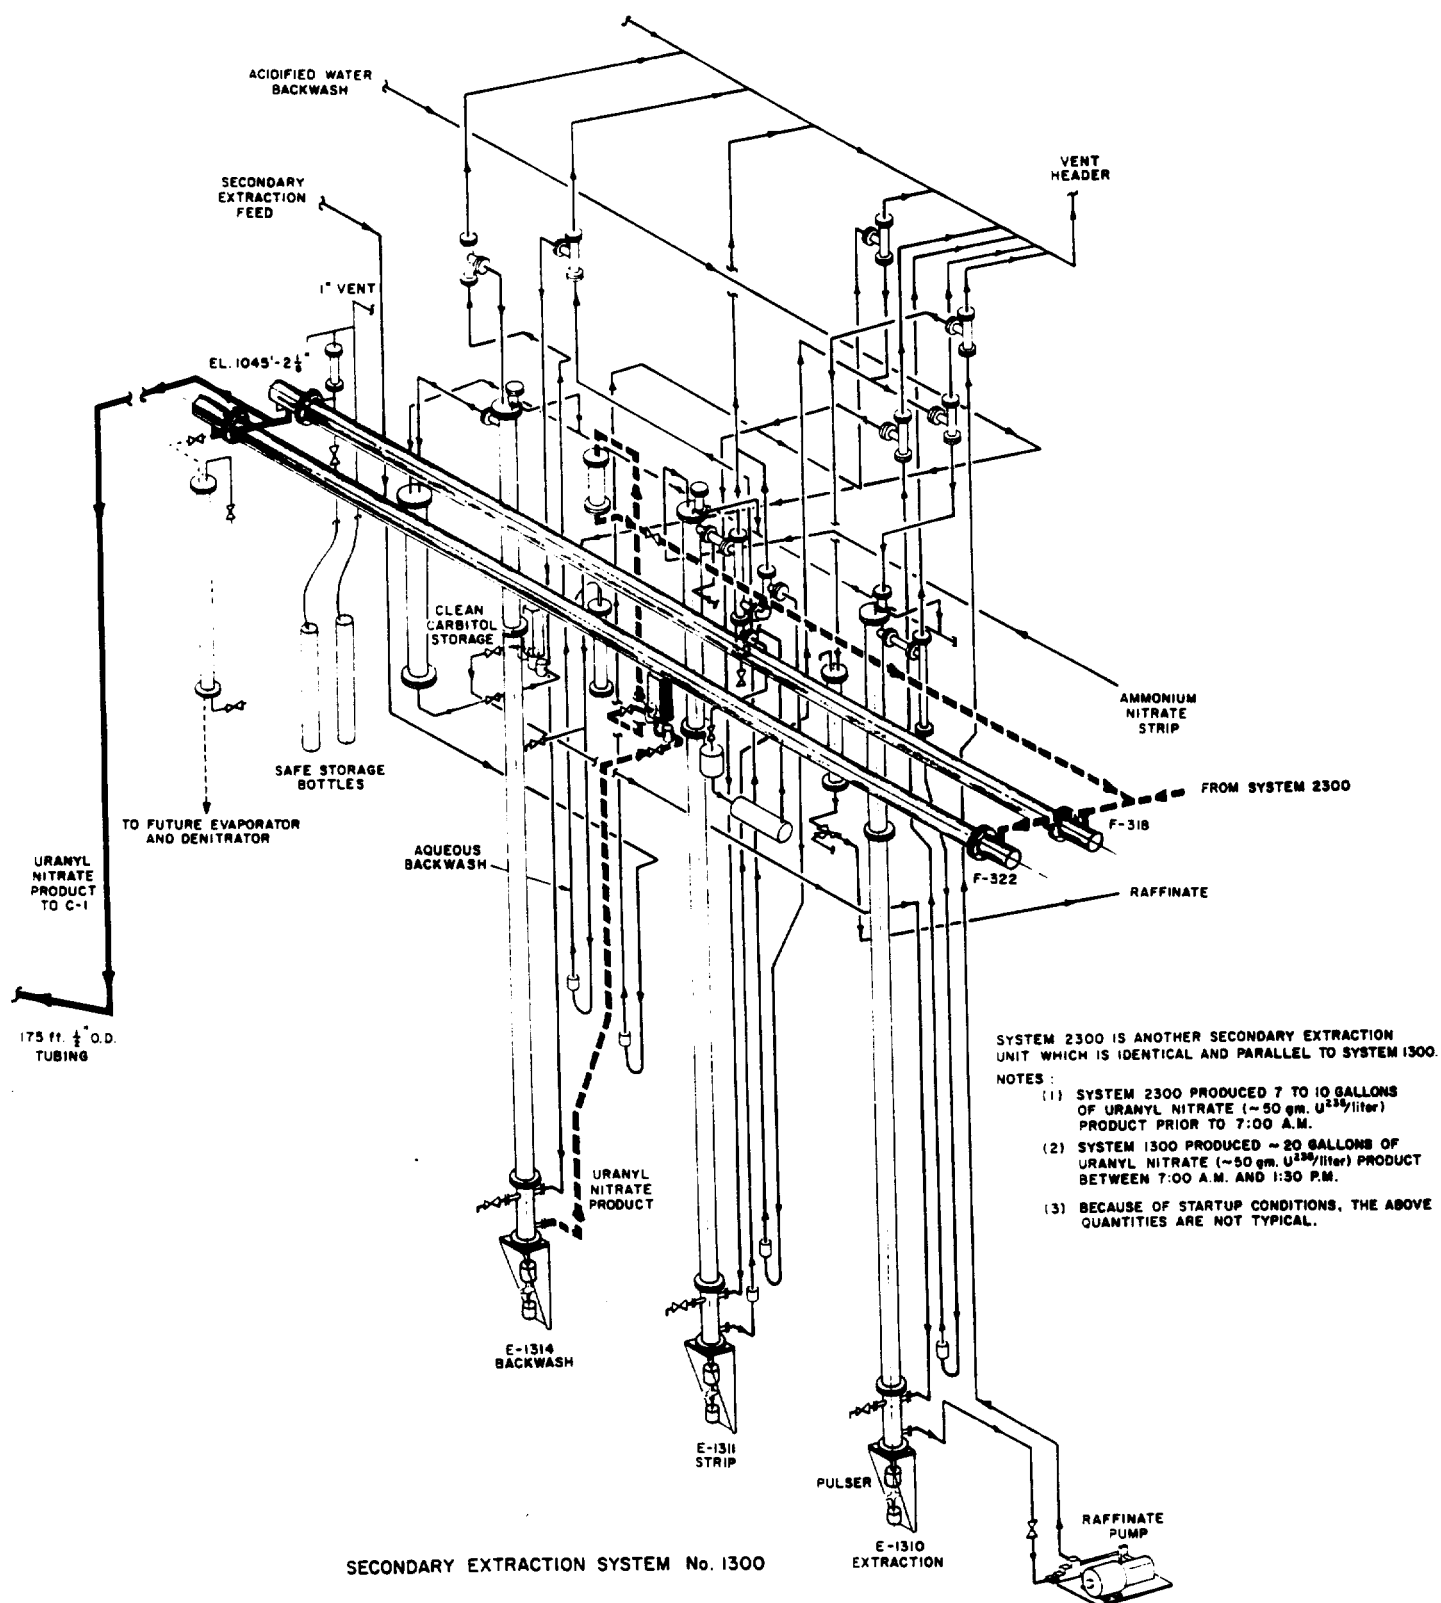
FIG. 10  
FLOWSHEET OF PROCESS EQUIPMENT  
INVOLVED IN THE ACCIDENT

transfer line. The primary control valve (V-1, in Figure 10) was located in C-1 Wing and was controlled by the C-1 Wing process foremen.

Upon receiving an affirmative answer, this supervisor observed that solution was leaking through valve V-2. (See Figure 10.) Foreman "Y" then closed valve V-2 which leads to the pH adjustment station. Valve V-1, which controls the flow of concentrated uranyl nitrate from B-1 Wing, was not checked.

A determination of the minimum opening at which valve V-1 would pass the solution required was made using the cadmium nitrate solution. The required flow of about 140 ml per minute can be obtained in the plant configuration if the valve is 1.2 turns opened or within slightly less than one turn of being closed.

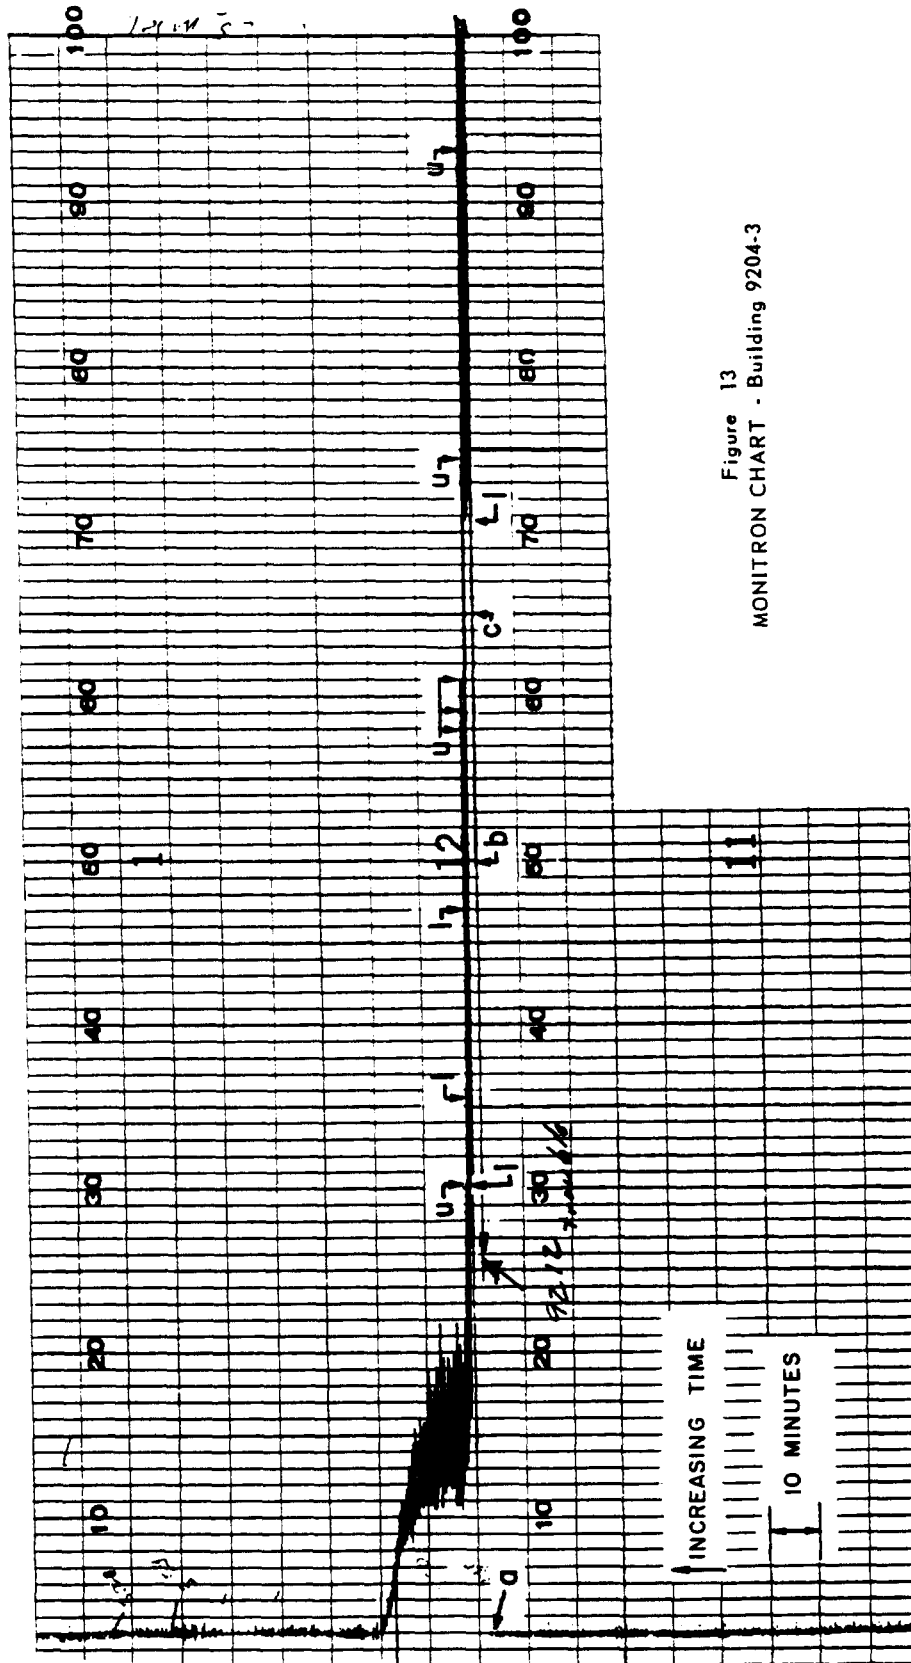
Figure 13  
MONITRON CHART - Building 9204-3

During the excursion a radiation detection instrument, sensitive to both neutrons and gamma rays, was operating in Building 9204-3 some 1400 ft. distant and cross wind from C-1 Wing of 9212. (See Figure 2.) The characteristics of the detector and its associated equipment are described in Appendix C. Figure 13 is a reproduction of its recorded trace during that time. The following discussion is based on a 7x enlargement of this record although most of the points are discernible on the reproductions shown here. Figures 14 and 15 are two parts of the enlargement illustrating some of the detail in the record. The radiation intensity is observed to first increase extremely rapidly from "a", Figure 13, driving the pen off scale, then decrease to "b", repeating to "c", all in about 15 seconds determined by the chart drive speed. During the next interval, the signal oscillated an indeterminate number of times, finally decreasing to about five times background, 2.8 minutes after the first rise in level. The upper and lower limits of some of these pulses, discernible on the enlarged trace, are indicated by "u" and "l", respectively. This (average) high-intensity field is then followed by a slowly decreasing level of some 18 minutes duration again characterized by pulses. One peak, at 61 on the scale, is separated inordinately in time from adjacent portions of the trace and may be due to a peculiarity of this detector, particularly since it is not readily identified on the charts from either of the air monitors referred

With reference to the power-level relation, indicated by the radiation monitor record described in Figure 13, the following sequence of conditions is suggested. In the absence of a source of neutrons, this system was prompt critical before any energy was emitted. Once started, however, the power level rose quite rapidly to a high value. The energy from these fissions produced gases by dissociation,<sup>3</sup> reducing the density and driving the solution subcritical. Exit of these gas bubbles once more made the system prompt critical and, with the delayed neutrons as a source, the power level again rose. This cycling persisted for an estimated 2.8 minutes, during which, of course, the temperature of the solution increased. Boiling\* finally ensued, causing a sharp decrease in density and a concomitant return to subcritical indicated by the decrease in the instrument deflection to about scale reading "20", Figure 13. Following this steep descent, the system settled into an equilibrium condition somewhere in the delayed critical range where it was controlled for about 18 minutes by vapor formation and, to a lesser extent, by decomposition gases. The system remained delayed critical until the inflow of water reduced the concentration to a final subcritical value.

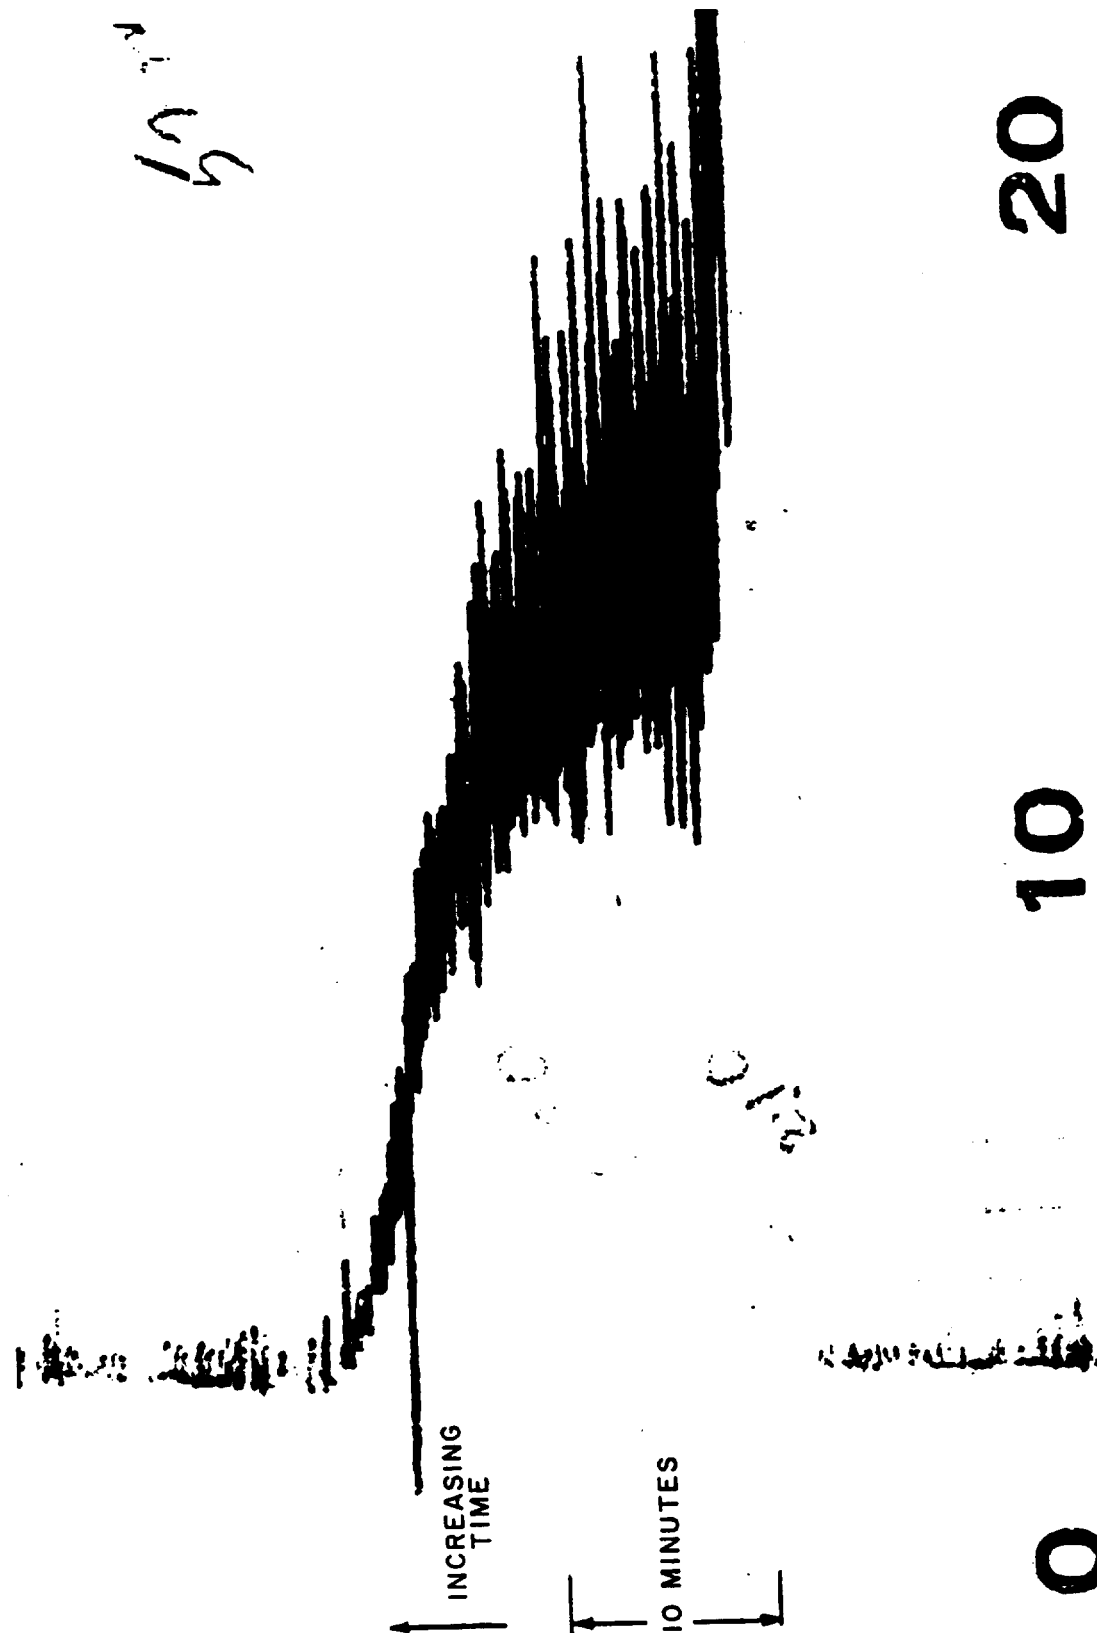
Figure 15  
BOTTOM SECTION OF MONITRON CHART  
Enlarged Approximately 4 Times

The enlargements, Figures 14 and 15, of the chart reproduced in Figure 13 were selected to illustrate qualitatively the power pulses which occurred during the excursion. They show the structure at full scale and during the extended period of relatively lower activity, respectively.

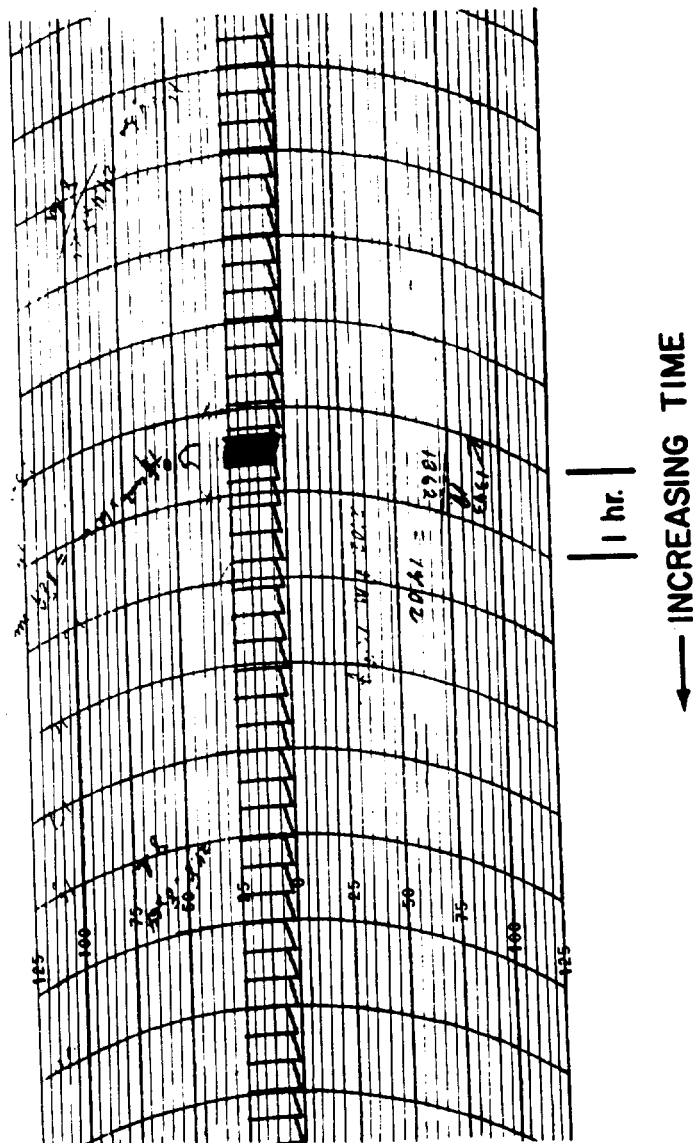
Figure 18  
MONITOR CHART  
Building 9204-3

The trace from end-window Geiger-tube instrument, shielded by 1½ in. of lead, is shown in Figure 18. This is one of about 12 such traces recorded by laboratory counters in the control room for the 63-inch cyclotron in Building 9204-3. Counts are accumulated through scaling circuits and activate the pulse recorder upon each accumulation of a preset number of counts. The individual register pulses were not discernible for any of these instruments except at the end of the excursion. However, the duration of the excursion was indicated by all of these instruments to be approximately 20 minutes.

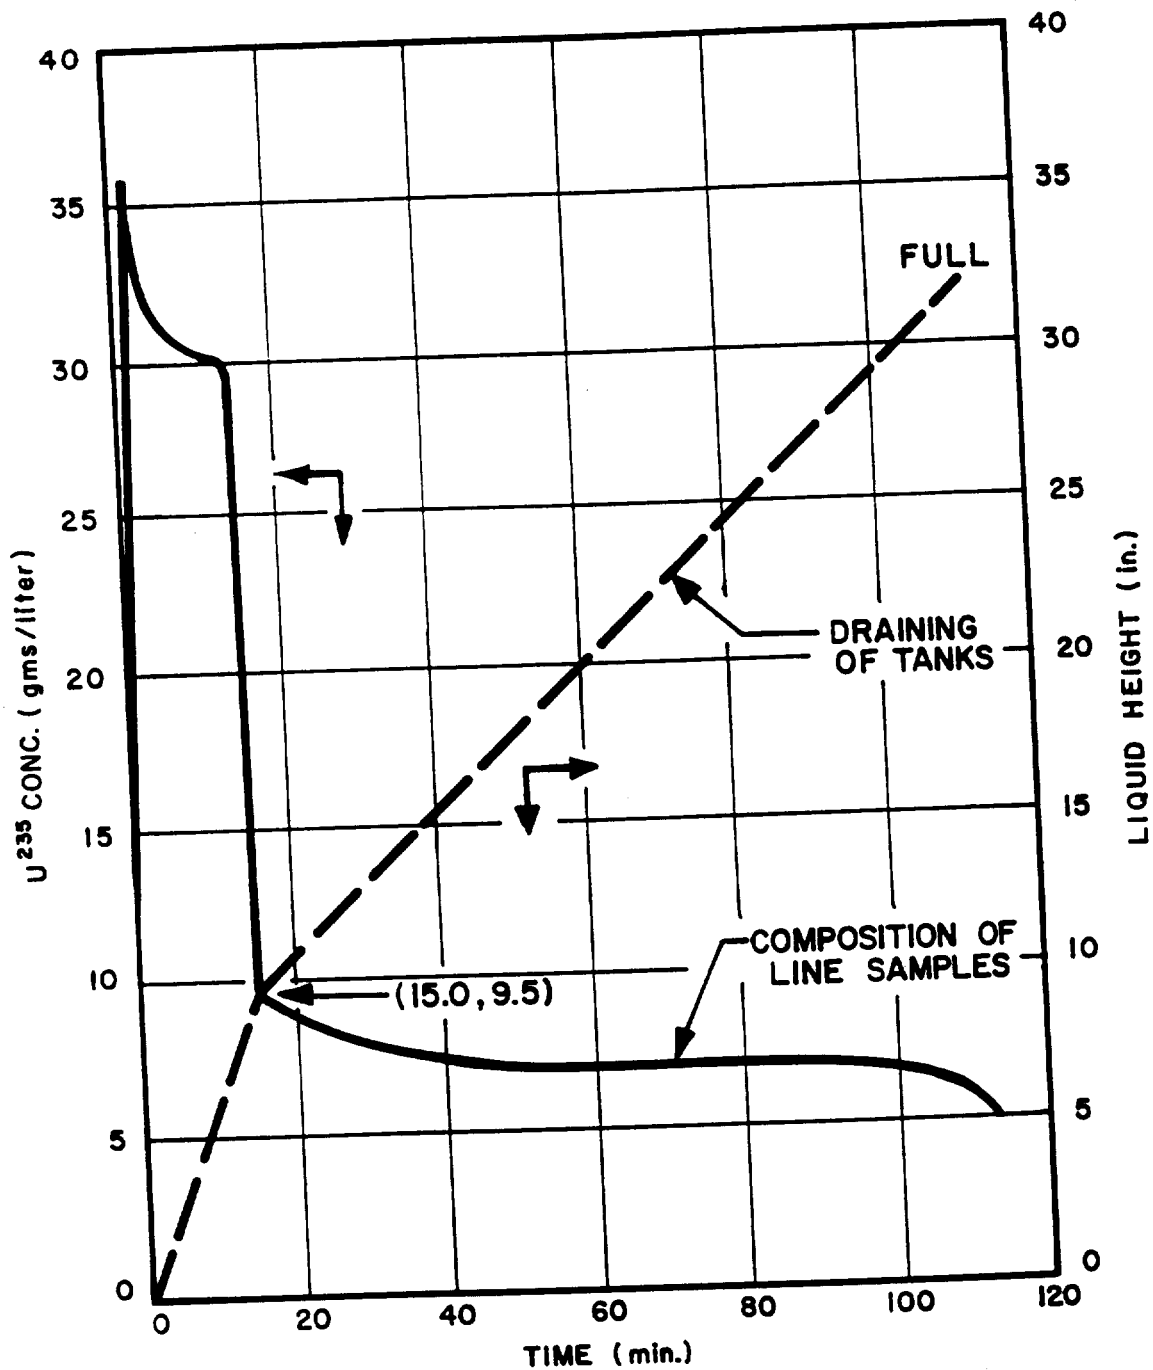
Figure D.1  
LIQUID HEIGHT AND CONCENTRATION OF  
SOLUTION IN DRUM AS FUNCTION OF TIME

Because of the small driving forces involved in the establishment of equilibrium between the tanks and of the tendency of the system to develop gas locks, the distribution of solutions obtained in the experiment may not duplicate that which occurred prior to the incident. Since there was good evidence of the flow of the solutions to all of the tanks involved in the experiment, it is believed that it constitutes a limiting case and that any other circumstances would have resulted in the uranium being added to the drum sooner because of failure to undergo dilution in the tanks. The rates of flow of the solutions from the tanks in the incident and the experiment should be very similar in any case.

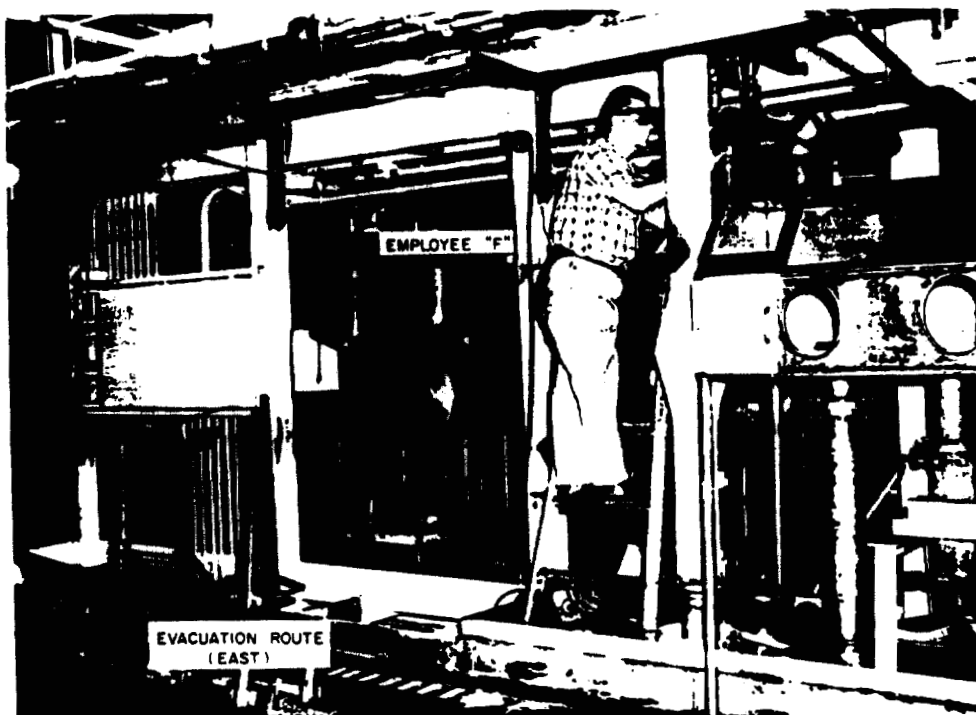
Figure M.2  
CLOSE-UP OF THE POSITION OF EMPLOYEE "F" ON MEZZANINE DIRECTLY  
ABOVE EMPLOYEE "C" AT THE TIME OF THE INCIDENT (Looking South)

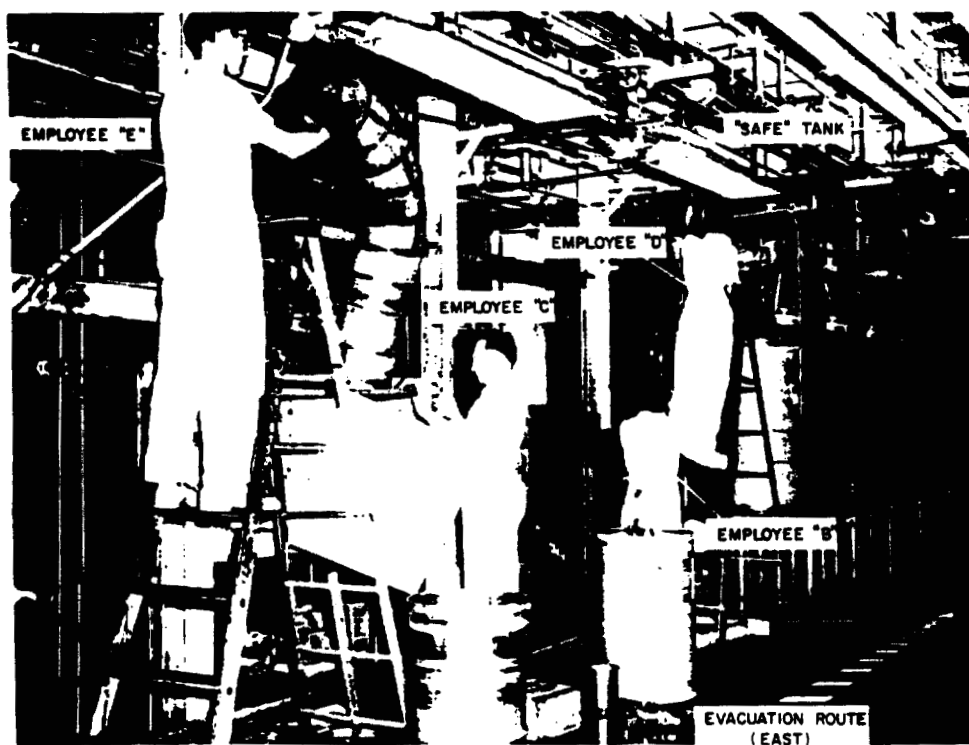
Figure M.3  
CLOSE-UP OF THE POSITIONS OF EMPLOYEES "E", "C", "B", AND "D"  
(Looking North East)
